Miscellaneous Paper SL-95-5  
December 1995

# Evaluation of Concrete Seawalls at Perry's Victory and International Peace Memorial

**Final report**

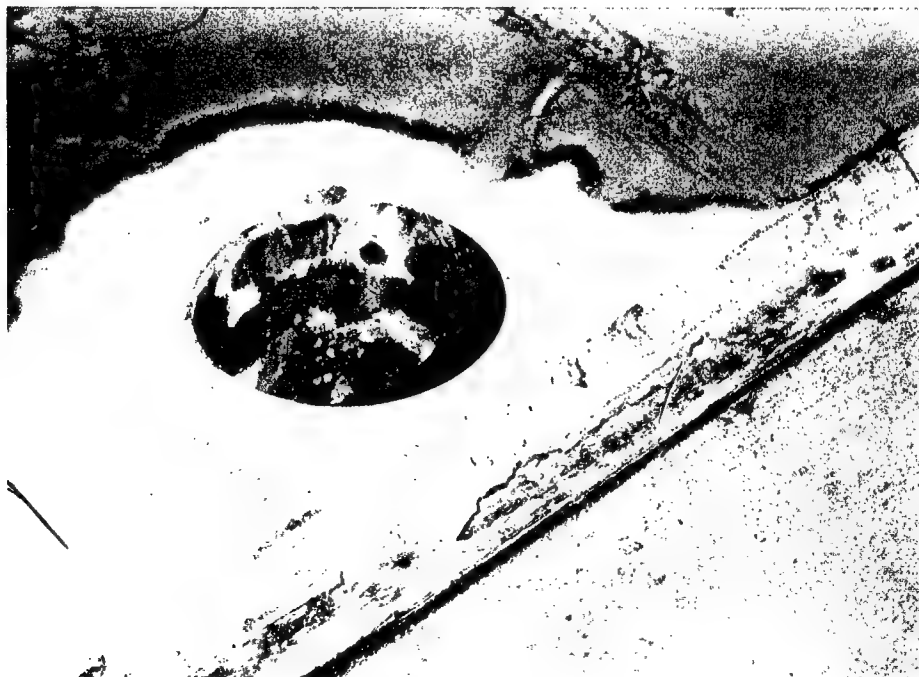
A visual inspection of the north seawall found that most of the distress and deterioration in the concrete was observed at the vertical joints. At a few of the joints, the distress was observed at both corners of the top surface and in the landside face (Figures 1 and 2). Localized distress was observed in the form of hairline cracks with a reddish-brown stain coming from some of the cracks at the ladder recess of monolith N22 (Figure 3). Moisture was retained in some of the aggregate visible in the surface of new borings (Figure 4).

Figure 4. Moisture retained in and around some of the aggregate particles visible in the surface of boring at joint 37/38, north seawall monolith N38

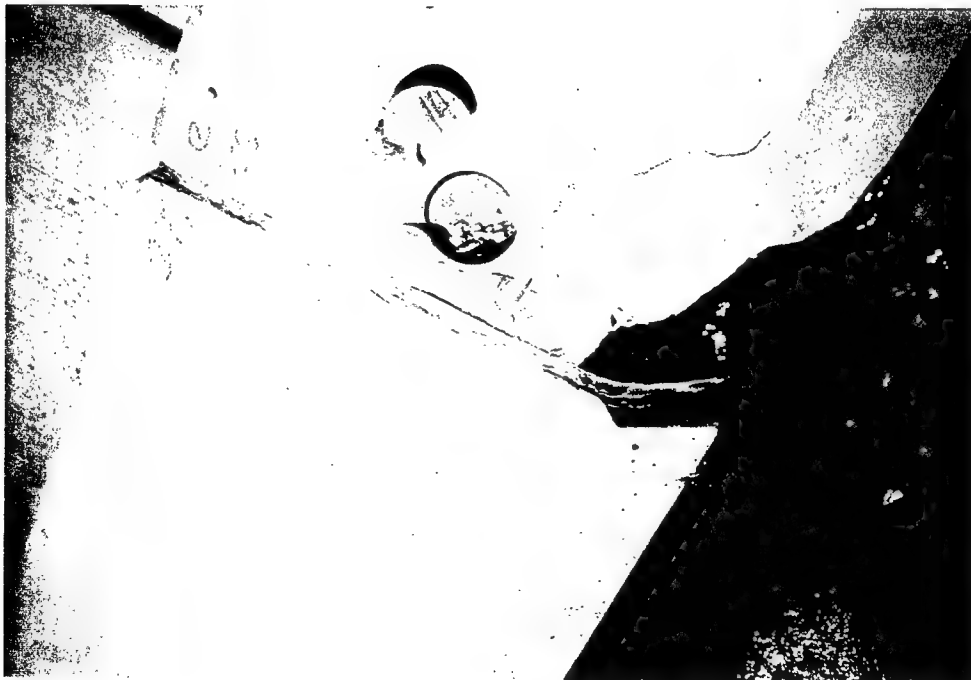
A visual inspection of the south seawall found that most of the distress and deterioration in the concrete was observed along the top-lakeside edges at the vertical joints (Figures 5 - 8). Extensive cracking was observed in the tops of four monoliths, S7, S16, S17, and S20 (Figures 9 -14). Areas of reddish-brown stains were observed coming from cracking along a longitudinal plane in landside (Figures 10 and 11) and lakeside faces of these monoliths.

Figure 6. Cracking along lakeside edge at joint 51/52, south seawall monolith S52

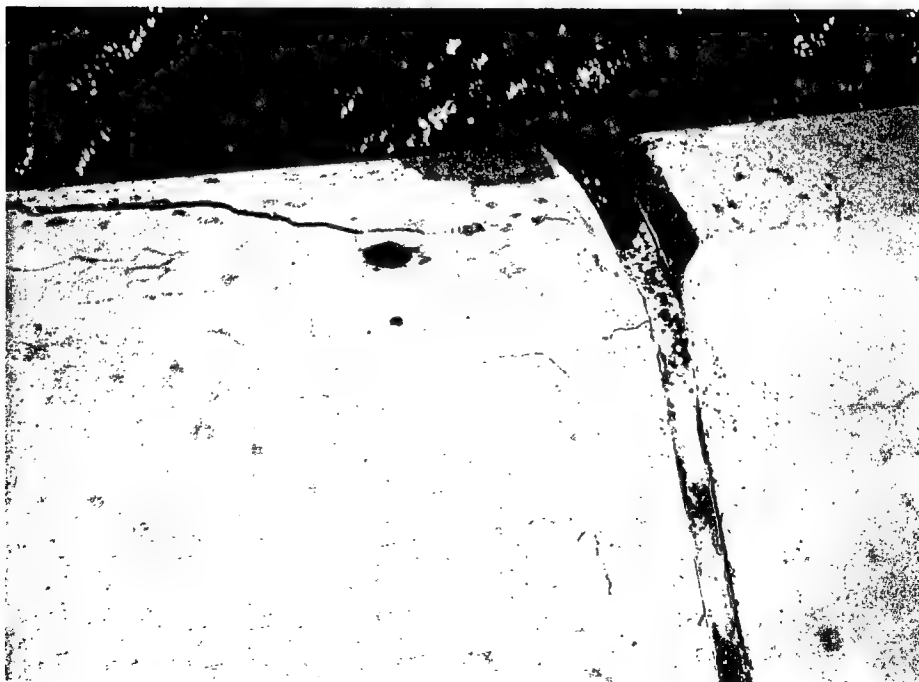
Figure 8. Cracking along lakeside edge at joint 71/72, south seawall monolith S72

S67*	Joint 67/68	Remove and replace from joint back approximately 610 mm (24 in.) and from top down 380 mm (15 in.)
S72*	Joint 71/72	Remove and replace from joint back approximately 610 mm (24 in.) and from top down 380 mm (15 in.)
S72*	Joint 72/73	Remove and replace from joint back approximately 610 mm (24 in.) and from top down 380 mm (15 in.)

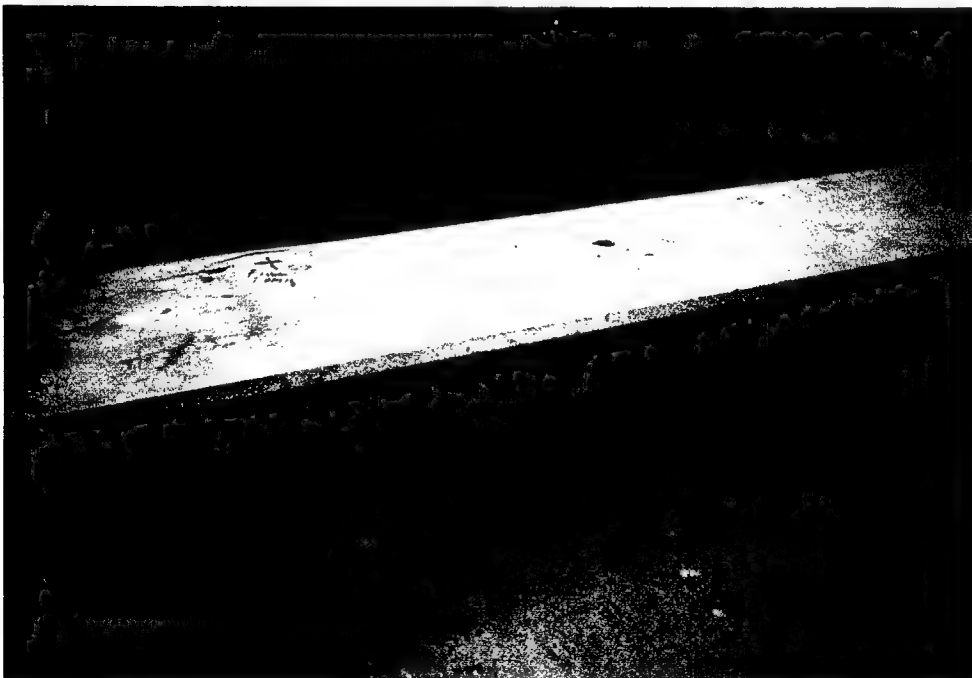
Figure 10. Cracks and stains in landside face of south seawall monolith S7

Corrosion of the reinforcing steel was indicated in the four south seawall monoliths by areas of reddish-brown stains coming from cracking along a longitudinal plane in landside and lakeside faces. Reddish-brown stains were also observed coming from cracks in the concrete at the ladder recess of north seawall monolith N22.

There are forty locations in the south seawall where distressed and deteriorated concrete should be consider for removal and replacement (Table 7). Four locations (monoliths S7, S16, S17, and S20) include removal and replacement of the top 460 mm (18 in.) of the monolith and the other thirty-six locations are for repairs at a joint. In general, it is recommended that for repairs at a joint the concrete be removed and replace from the joint back approximately 610 mm (24 in.) and from the top down approximately 380 mm (15 in.).

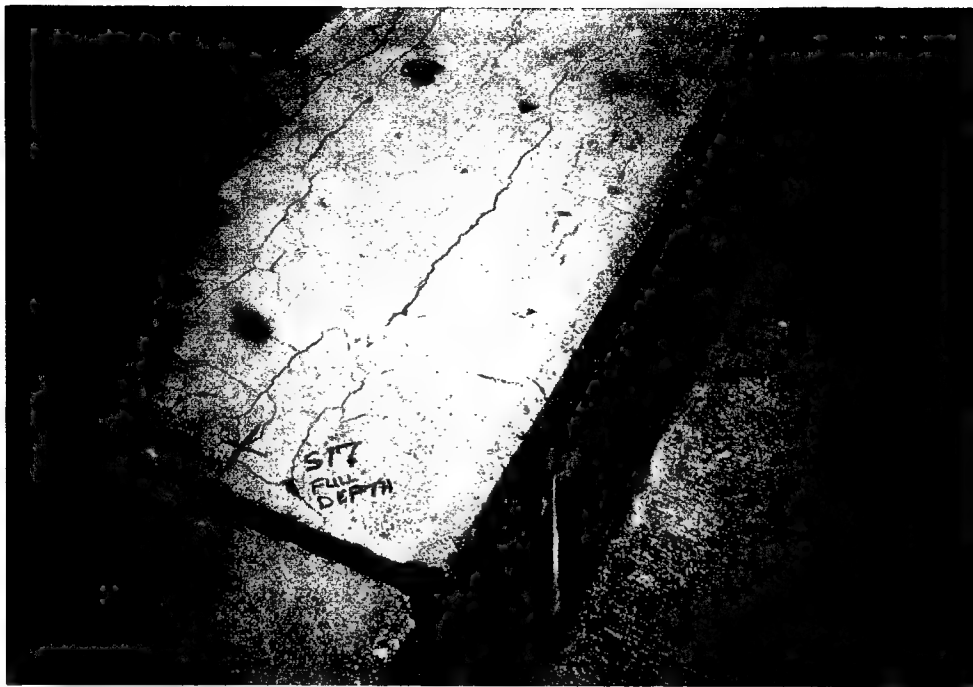
Figure 11. Cracks and stains in faces of south seawall monolith S17 at joint 17/18

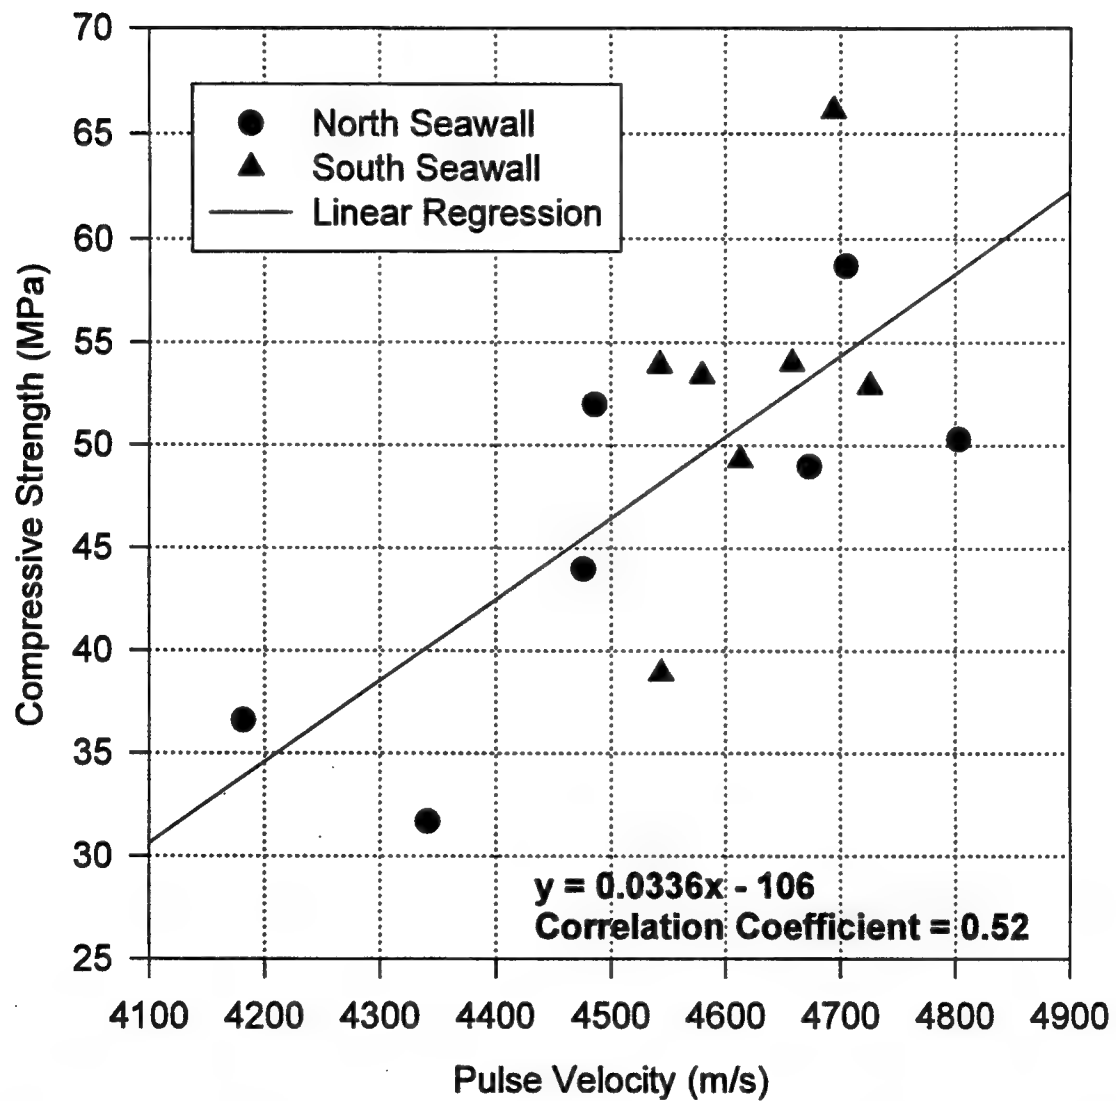
Figure 18. Compressive strength vs pulse velocity for core samples

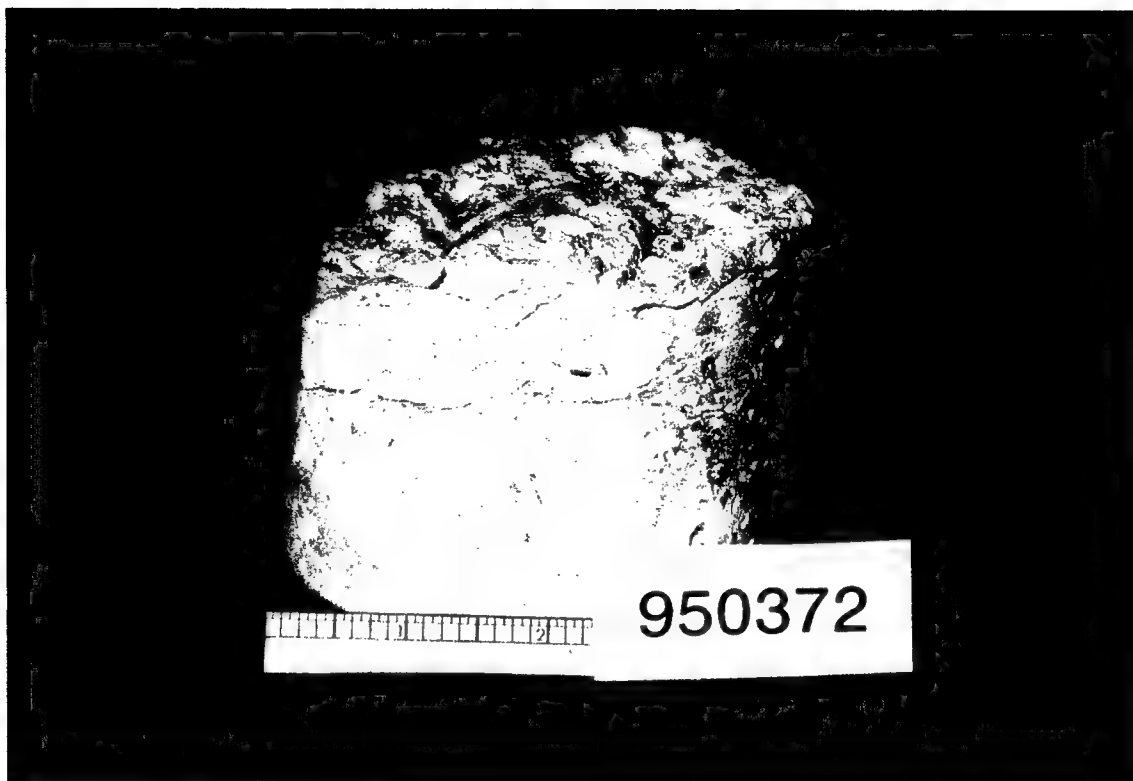
Figure B-29. Cracking parallel to top surface of structure (bottom of photo) occurs several inches below surface and cannot be detected by visual examination

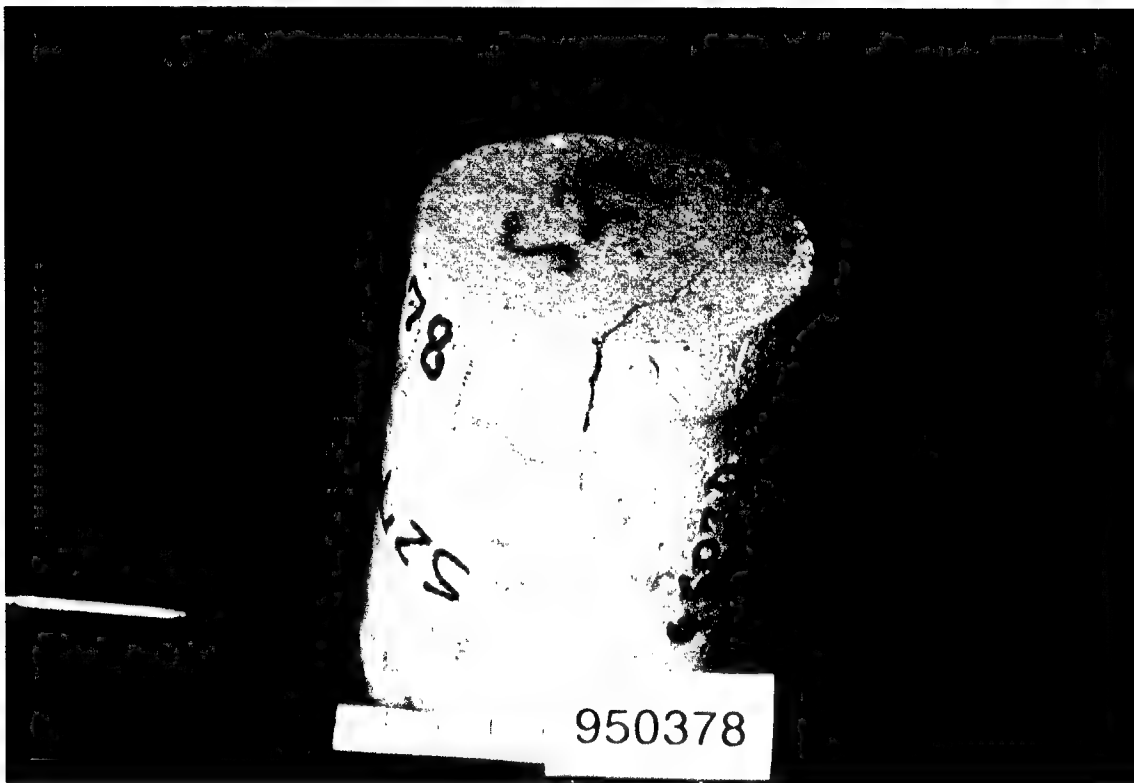
Figure B-30. Vertical crack in sample 950378 goes to the surface of the concrete
